Name of Dam: Bernhart Dam

County and State: Berks County, Pennsylvania

Inventory Number: PA 00717

PHASE I. INSPECTION REPORT

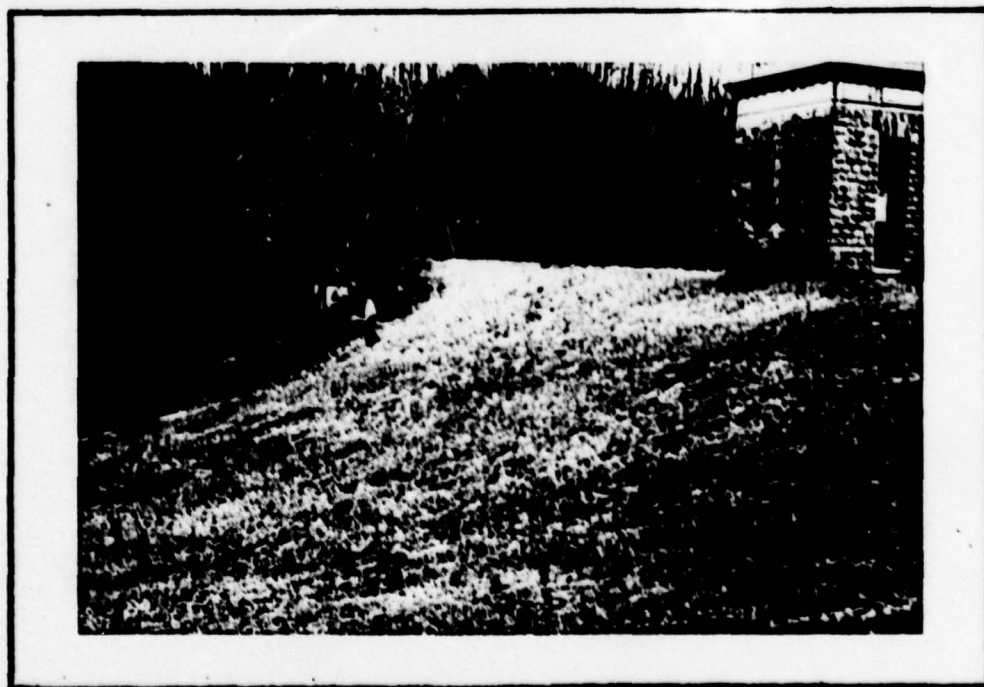
DOWNSTREAM FACE OF THE DAM

- b. Dam. The downstream face of the embankment appears to be in good condition. The only visible portion of the upstream face is the masonry wall which extends 5 feet above the reservoir surface. The masonry appears to be in good condition, but several small trees are growing from cracks in the upstream face of the wall. The grass cover has been eroded away and a path has formed along the crest and downstream slope at the spillway junction. This is apparently the result of pedestrian traffic and surface runoff.
